# INSPECTION REPORT

For the Property at:  
**123 TEST INSPECTION BLVD SW**  
CALGARY, AB T2W5Z9

Prepared for: JOHN & JANE SMITH  
Inspection Date: Sunday, March 5, 2017  
Prepared by: Shawn Paradis

RE: Report No. 1004, v.2  
123 TEST INSPECTION Blvd SW  
Calgary, AB  
T2W5Z9

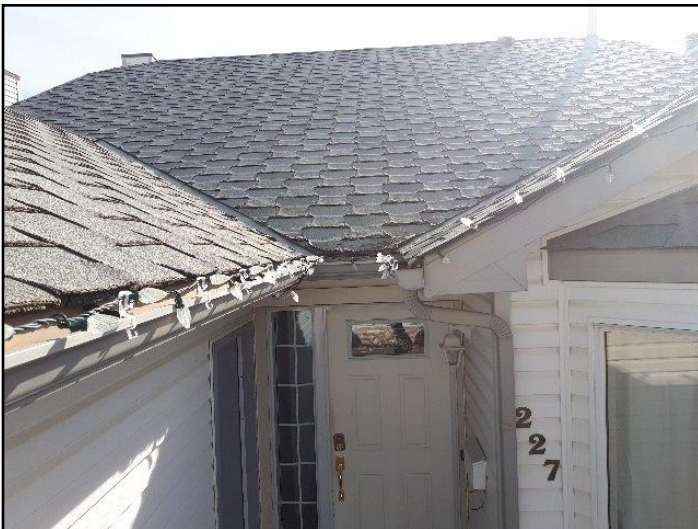
1. Old, worn out

2. **Condition:** • [Old, worn out](#)

**Implication(s):** Chance of water damage to contents, finishes and/or structure

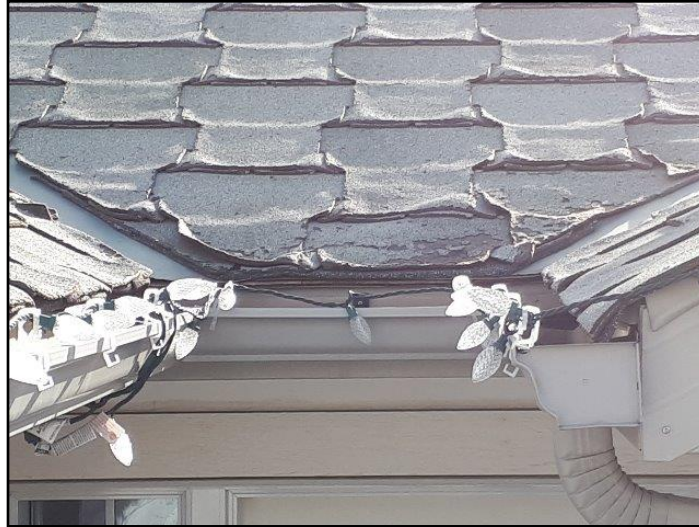
3. *Cupping, curling, clawing*

## 4. Condition: • [Cupping, curling, clawing](#)

shingles curling

**Implication(s):** Chance of water damage to contents, finishes and/or structure

**Task:** Replace

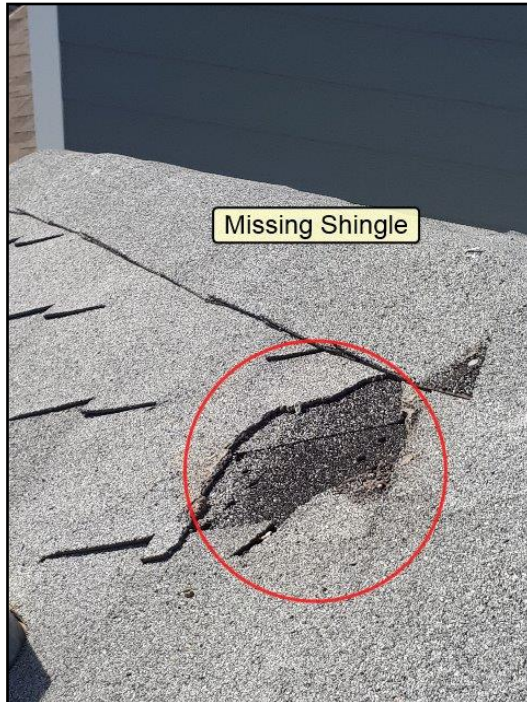
4. Missing, loose or torn

## 6. Condition: • [Missing, loose or torn](#)

Missing shingles, minor roof leak

**Implication(s):** Chance of water damage to contents, finishes and/or structure

**Task:** Repair or replace

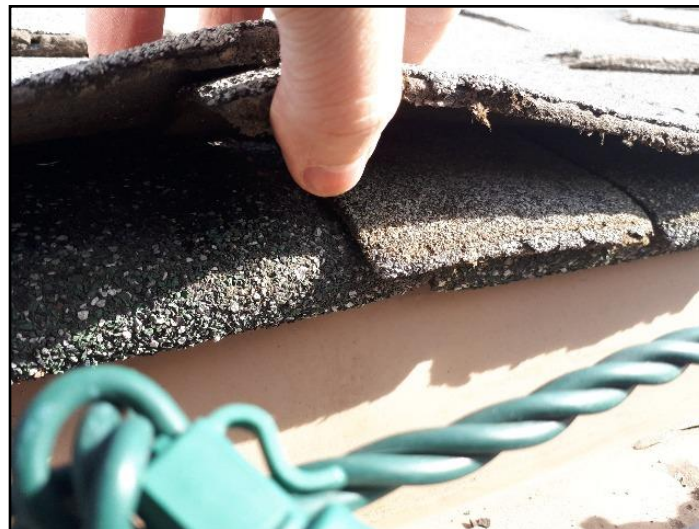
6. Multiple layers

## 7. Condition: • [Multiple layers](#)

**Task:** Replace

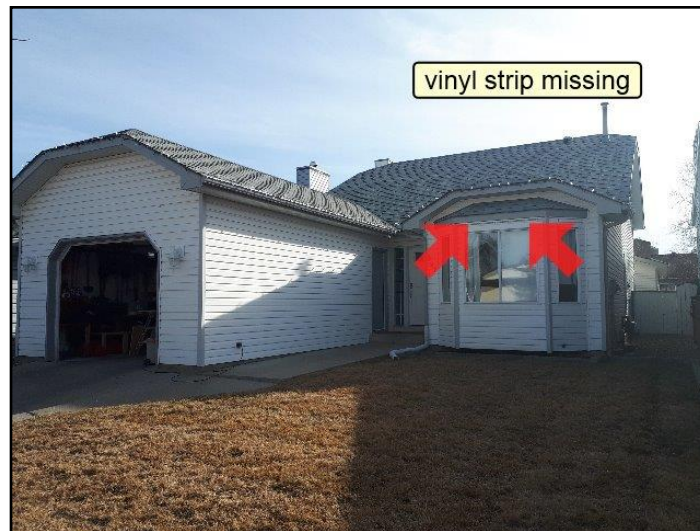
7. Missing

### 9. Condition: • [Missing](#)

A piece of vinyl flashing is missing over the living room window

**Implication(s):** Chance of water damage to contents, finishes and/or structure

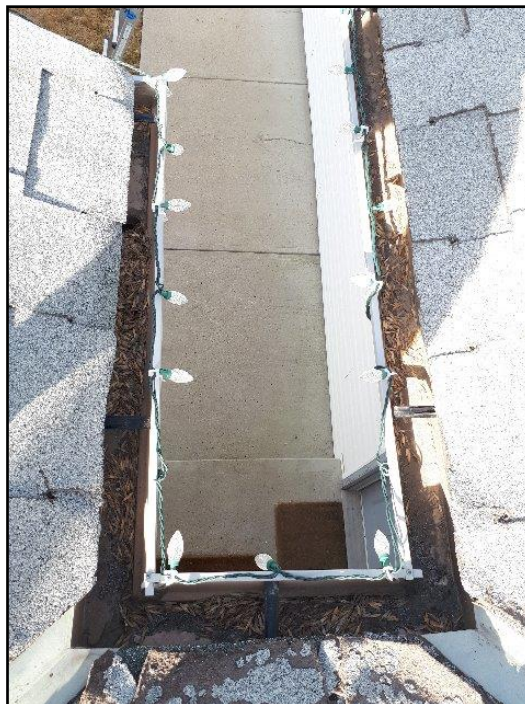
8. Clogged

**10. Condition:** • [Clogged](#)

A lot of Debris observed in gutters

**Implication(s):** Chance of water damage to contents, finishes and/or structure

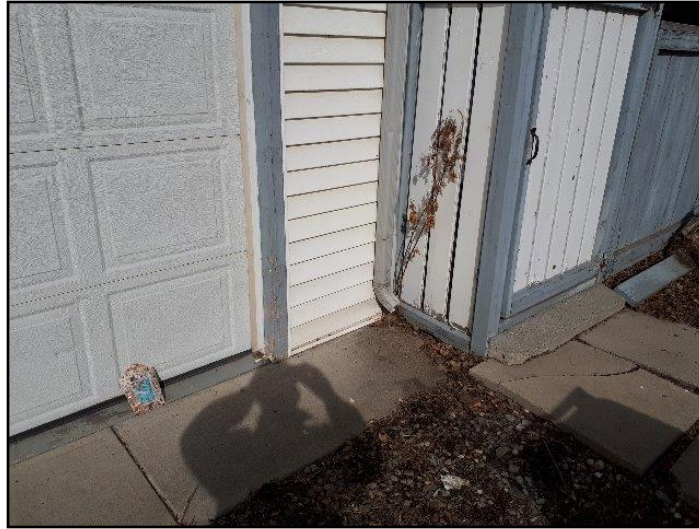
9. Downspouts end too close to building

**12. Condition:** • [Downspouts end too close to building](#)

discharge too close to building

**Implication(s):** Chance of water damage to contents, finishes and/or structure

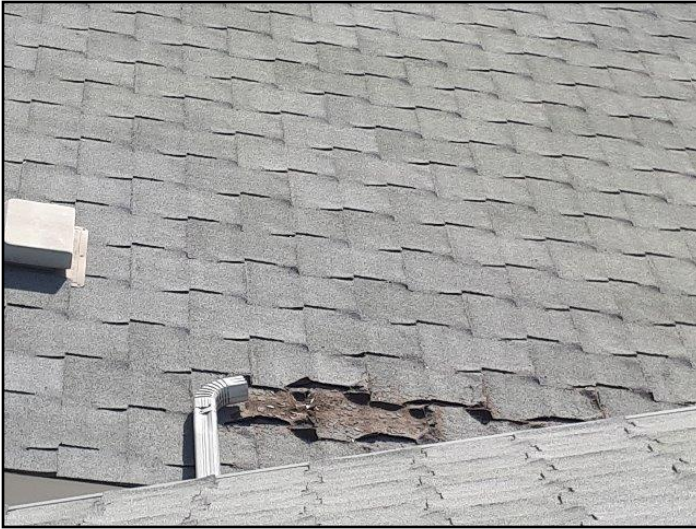
10. Discharging onto roof

## 13. Condition: • [Downspouts discharging onto roofs](#)

Roof Damage from water discharge on East Garage

**Implication(s):** Chance of water damage to contents, finishes and/or structure

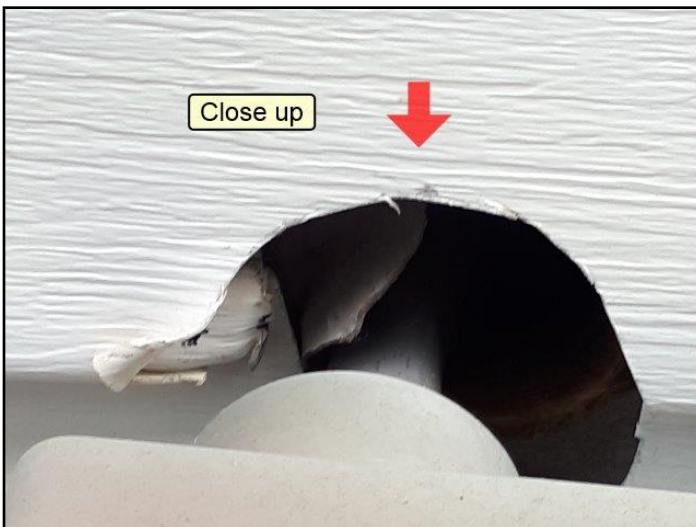
12. Mechanical damage

### 15. Condition: • [Mechanical damage](#)

Mechanical Damage to siding on South Side phone, gas and cable entrances

**Implication(s):** Chance of water damage to contents, finishes and/or structure

**Task:** Improve

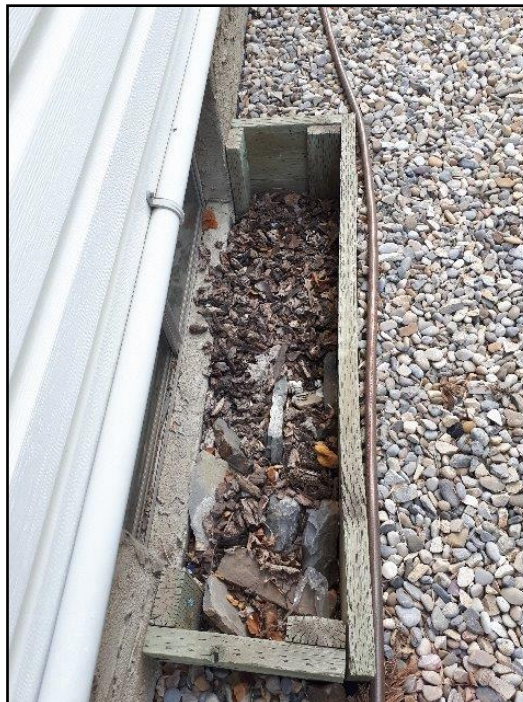
14.

**17. Condition:** • window well full of debris

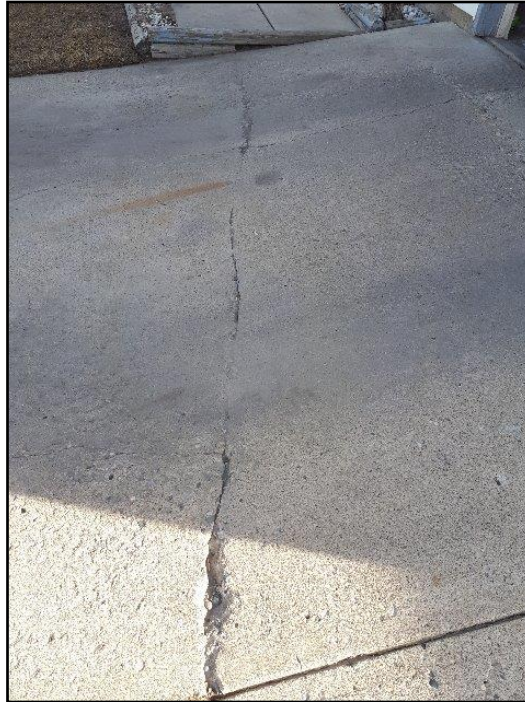
15. Cracked or damaged surfaces

**19. Condition:** • [Cracked or damaged surfaces](#)

**Implication(s):** Trip or fall hazard

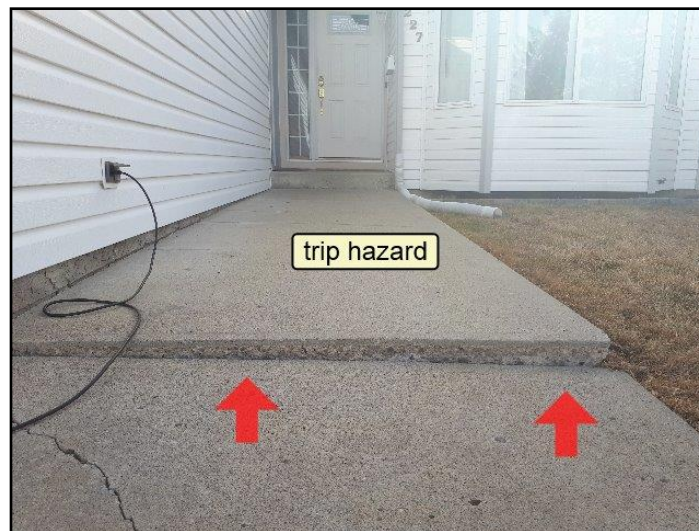
16. Uneven (trip hazard)

**20. Condition:** • [Uneven \(trip hazard\)](#)

Trip hazard at main entrance walkway (sinking concrete slab)

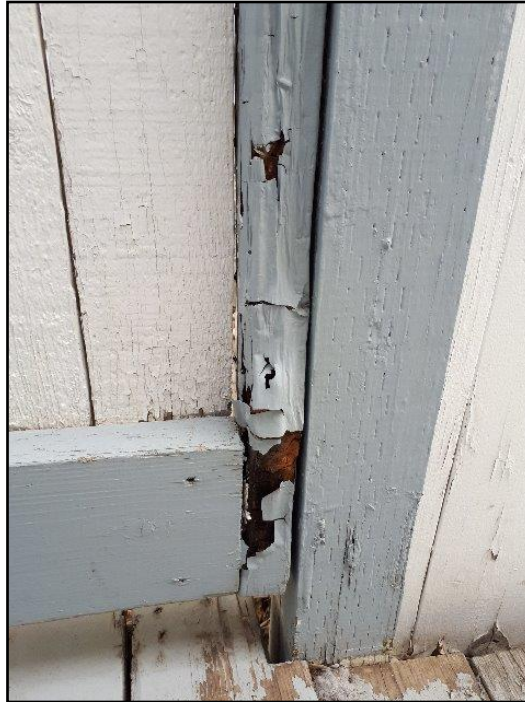
17. Boards damaged

21. **Condition:** • Boards damaged

Rot observed

**Implication(s):** Material deterioration | Poor security

**Task:** Repair or replace

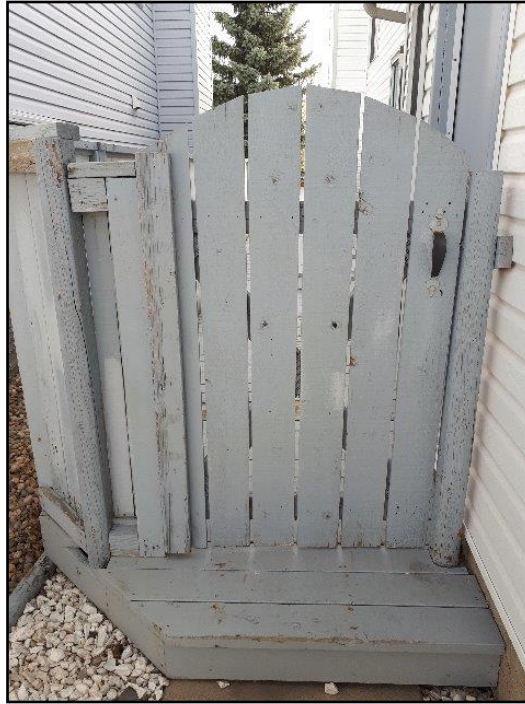
18. Gate - adjustment needed

**24. Condition:** • Gate - adjustment needed

**Task:** Repair

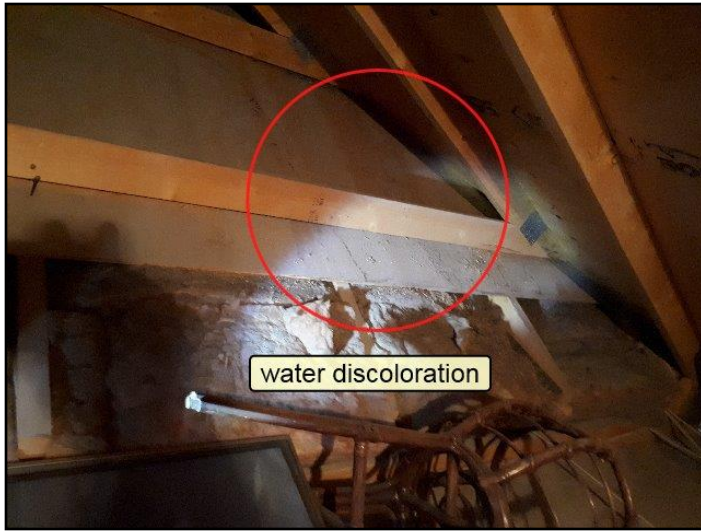
19. Water stains

**31. Condition:** • [Water stains](#)

Water stains on sheathing in both attics

**Implication(s):** Material deterioration

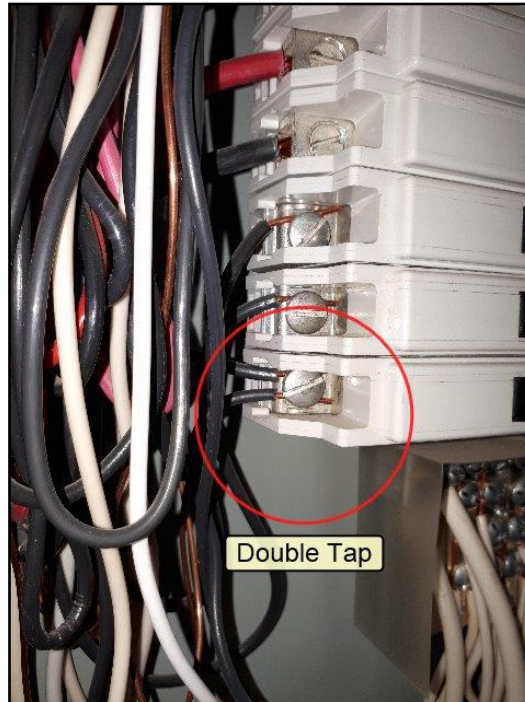
23. Double taps

**32. Condition:** • [Double taps](#)

**Implication(s):** Fire hazard

**Task:** Further evaluation

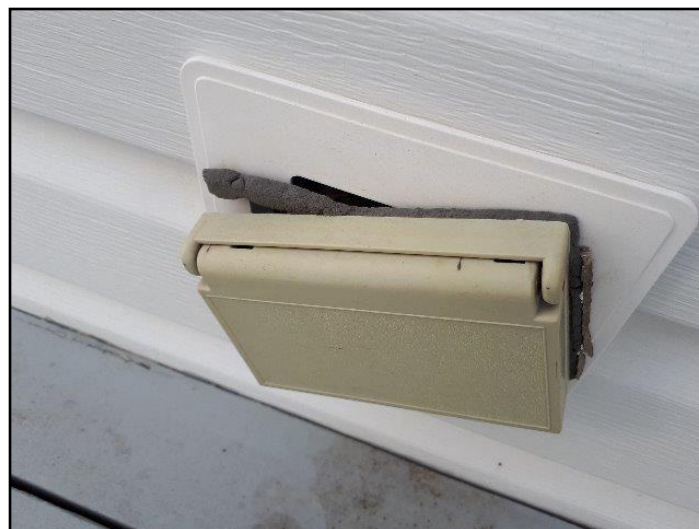
24. Loose

33. Condition: • [Loose](#)

Loose exterior power receptacle

**Implication(s):** Electric shock | Fire hazard

**Task:** Repair

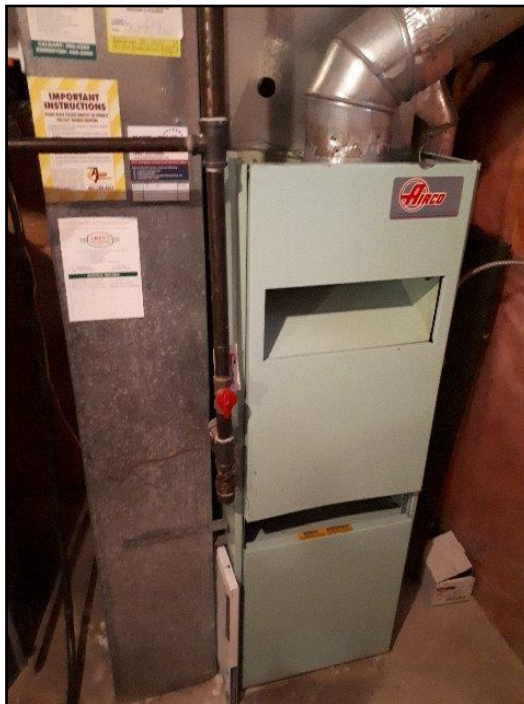
25. Near end of life expectancy

**34. Condition:** • [Near end of life expectancy](#)

**Implication(s):** Equipment failure | No heat for building

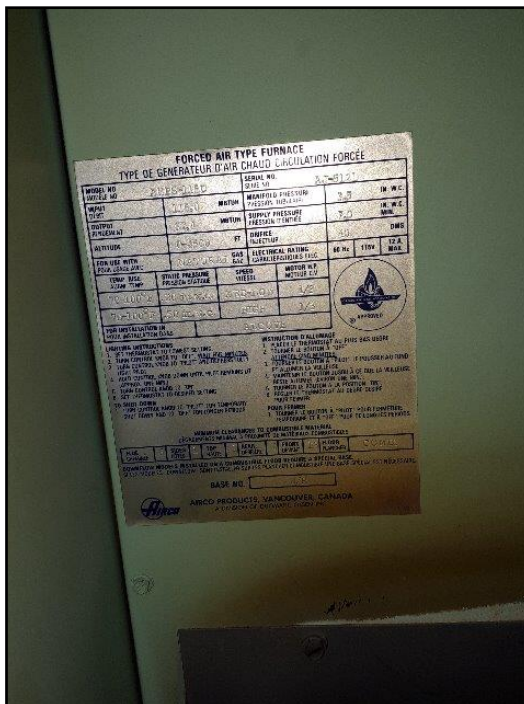
26. Old

35. Condition: • Old

Implication(s): Equipment failure | No heat for building

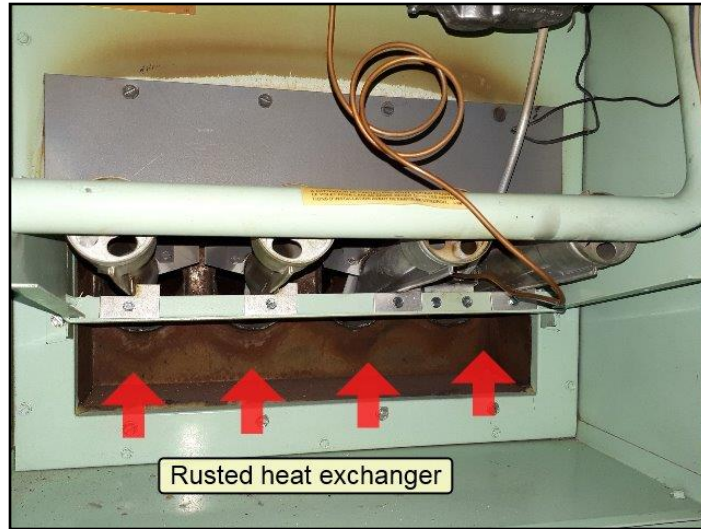
27. Soot or deposits

41. Condition: • [Soot or deposits](#)

Rusted heat exchanger, soot deposits

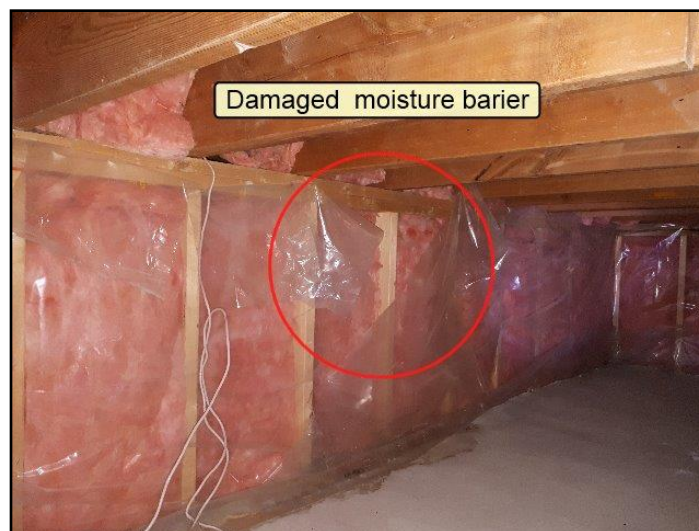
28. Other

43. Condition: • Other

Damaged Air/Vapor Barrier

Task: Repair

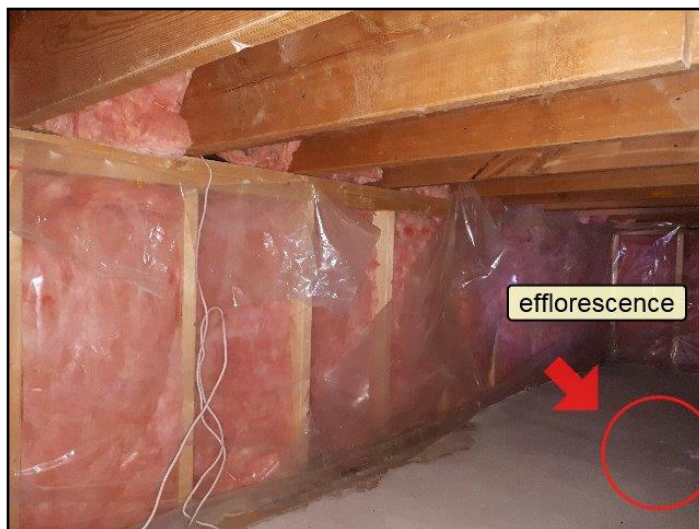
29.

**46. Condition:** • Efflorescence

**Implication(s):** Concrete deterioration over time

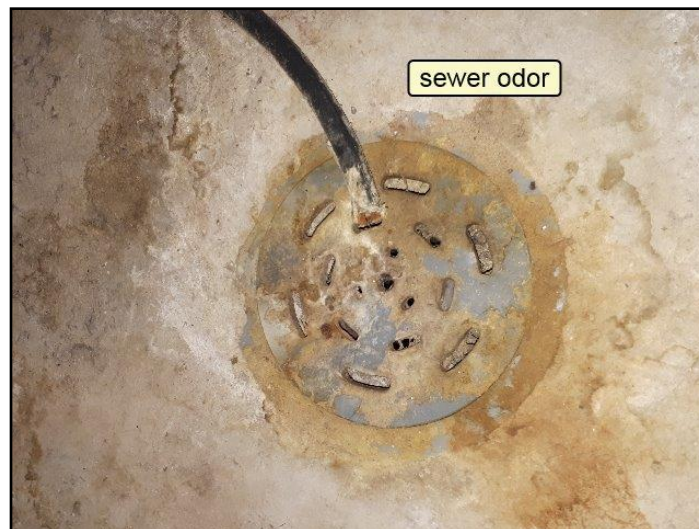
31. No trap

### 48. Condition: • [No trap](#)

**Task:** Improve

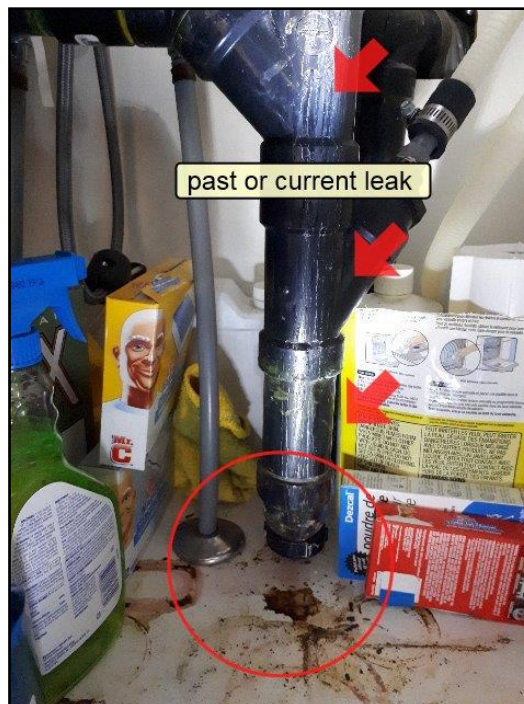
32. Leak

**51. Condition:** • [Leak](#)

Suspected past drain leak, contents dry at inspection

**Implication(s):** Chance of water damage to contents, finishes and/or structure | Sewage entering the building

**Task:** Monitor

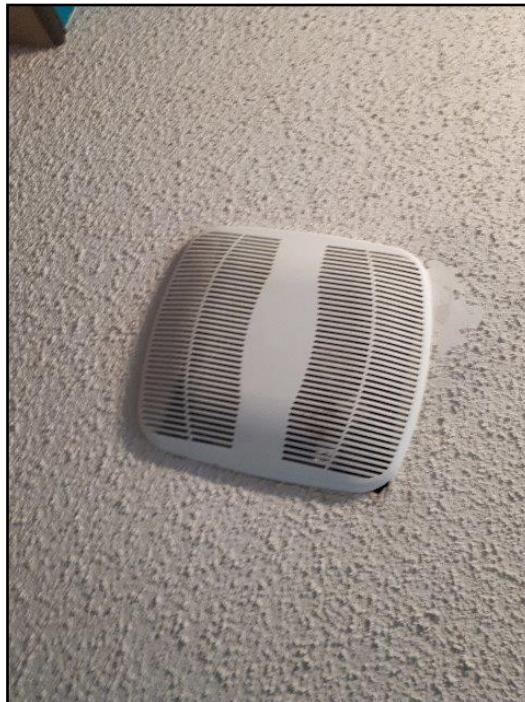
**33.** *Old*

**65. Condition:** • Old

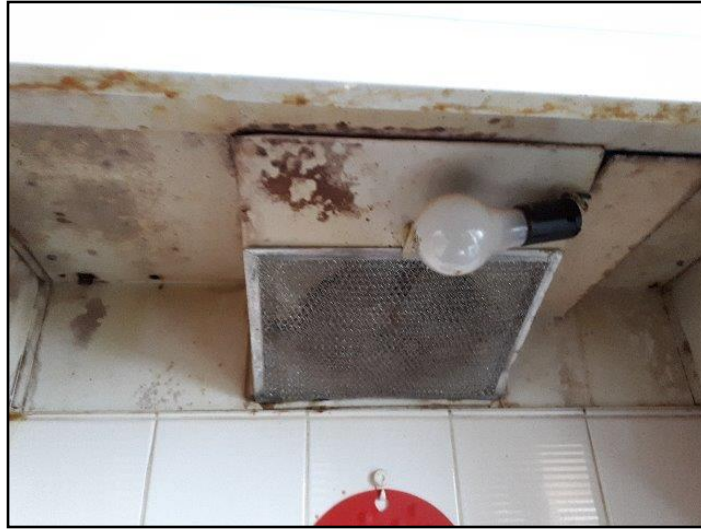
34. *Dirty filter*

**66. Condition:** • Dirty filter

Dirty Filter, Rust & Noisy
