# INSPECTION REPORT

For the Property at:  
**123 TEST INSPECTION BLVD SW**  
CALGARY, AB T2W5Z9

Prepared for: JOHN & JANE SMITH  
Inspection Date: Sunday, March 5, 2017  
Prepared by: Shawn Paradis

RE: Report No. 1004, v.2  
123 TEST INSPECTION Blvd SW  
Calgary, AB  
T2W5Z9

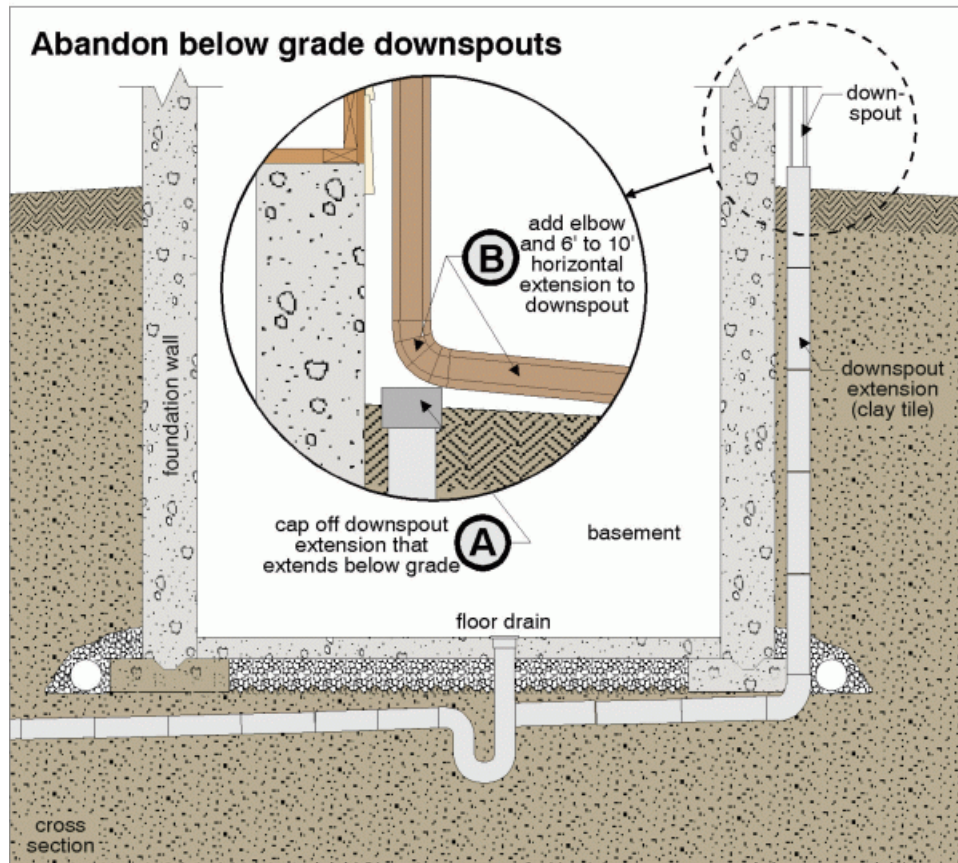
11. Condition: • [Downspouts discharging below grade](#)

**Implication(s):** Chance of water damage to contents, finishes and/or structure

**Task:** Monitor

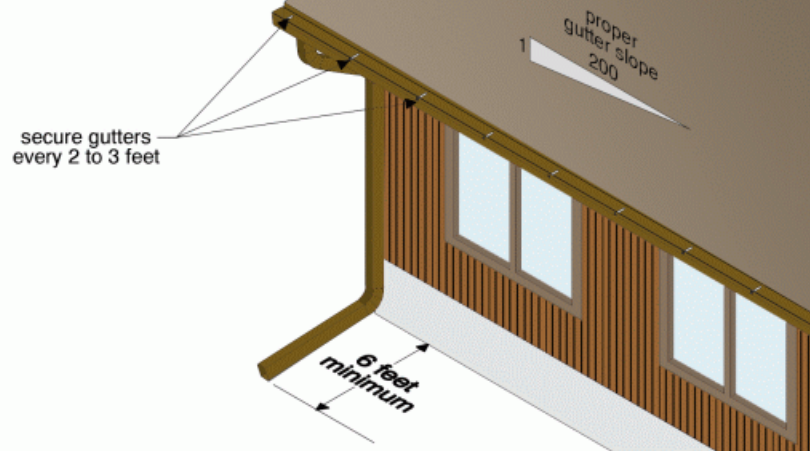
**12. Condition:** • [Downspouts end too close to building](#)

discharge too close to building

**Implication(s):** Chance of water damage to contents, finishes and/or structure

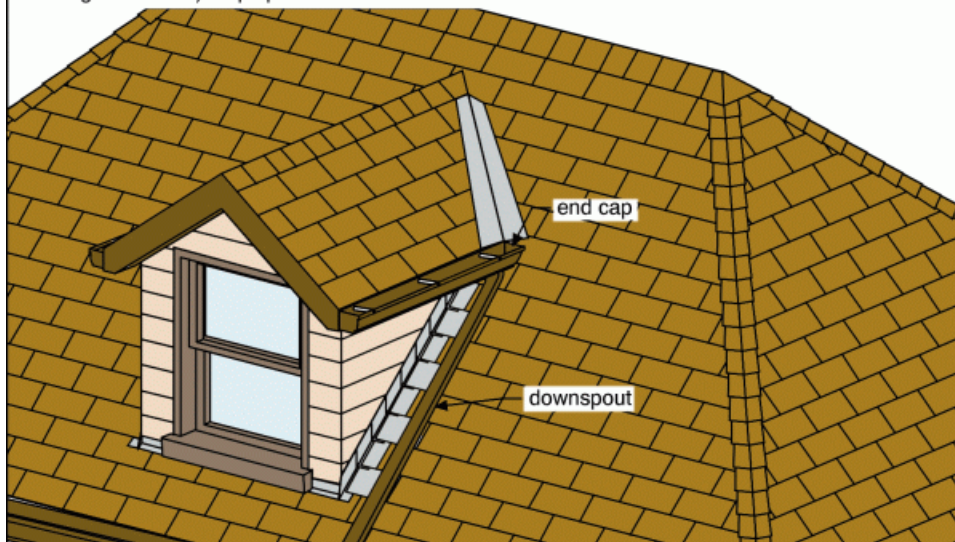
## 13. Condition: • [Downspouts discharging onto roofs](#)

Roof Damage from water discharge on East Garage

**Implication(s):** Chance of water damage to contents, finishes and/or structure

installing a downspout (from the secondary roof to the main gutter below) helps prevent localized roof wear

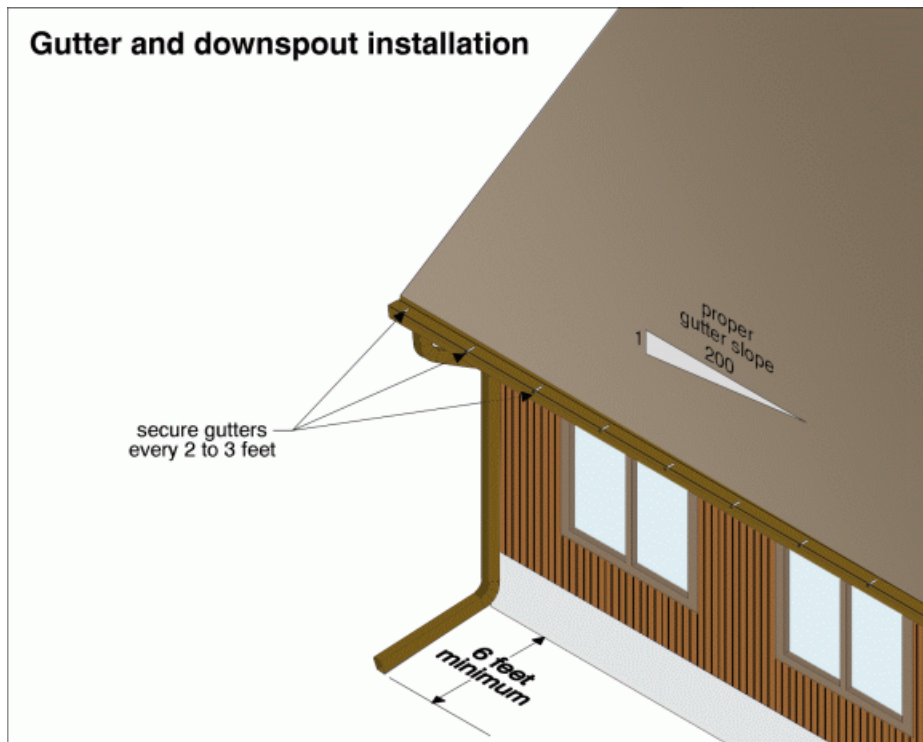
14. Condition: • [Should discharge 6 feet from building](#)

Implication(s): Chance of water damage to contents, finishes and/or structure

Location: Throughout

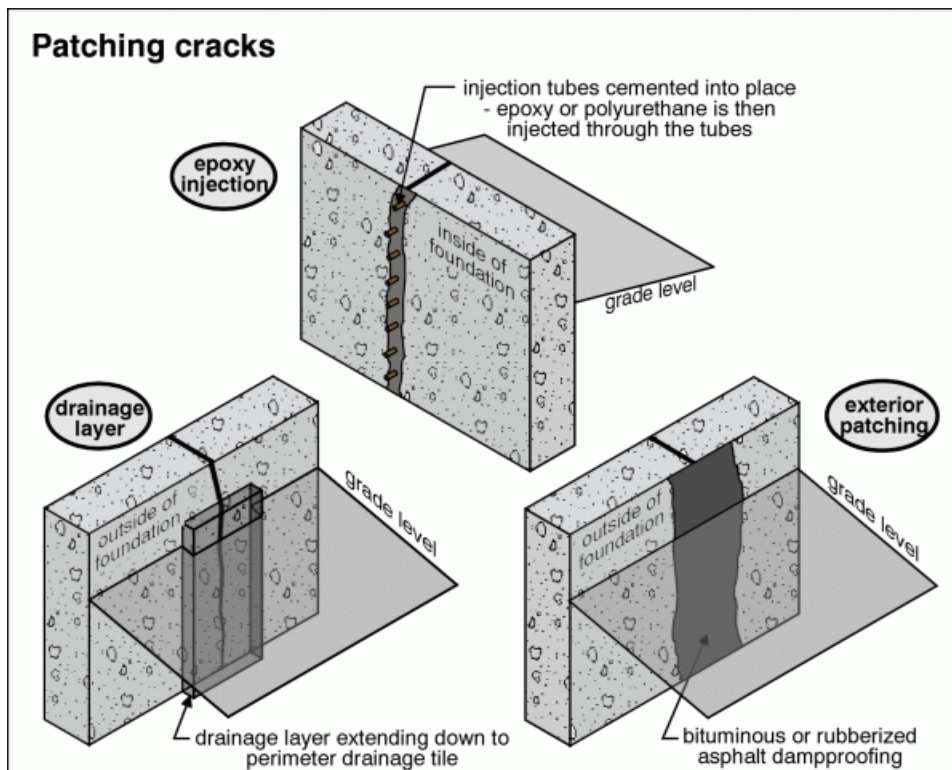
**Implication(s):** Chance of water entering building

**Location:** Various Crawl Space

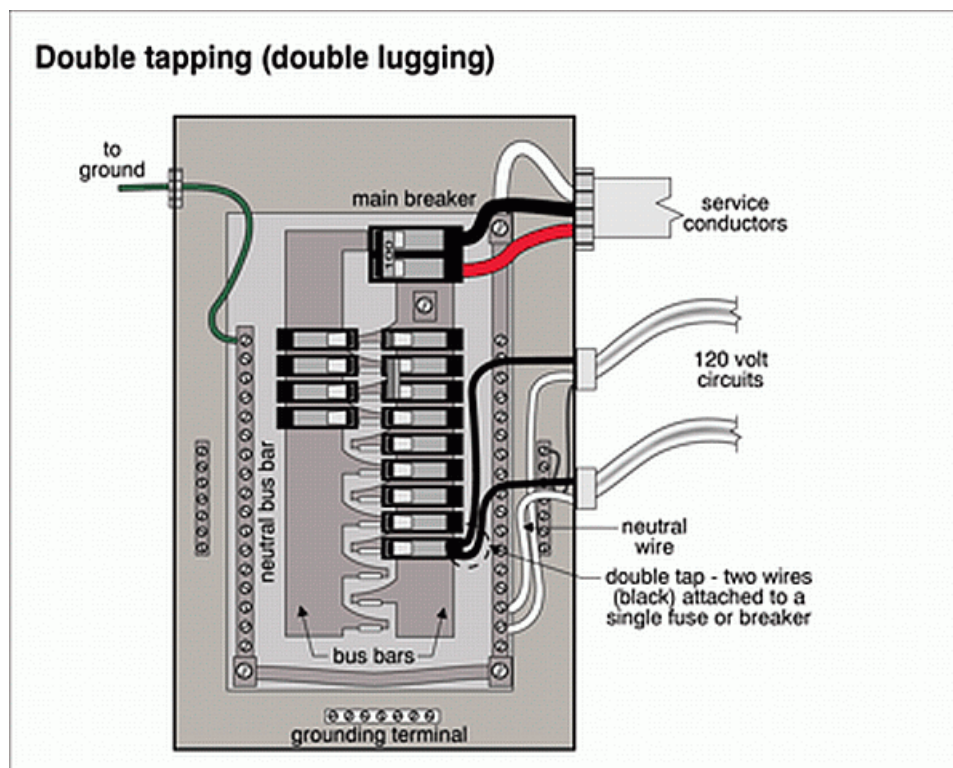
23. Double taps

**Location:** Basement

**Task:** Further evaluation

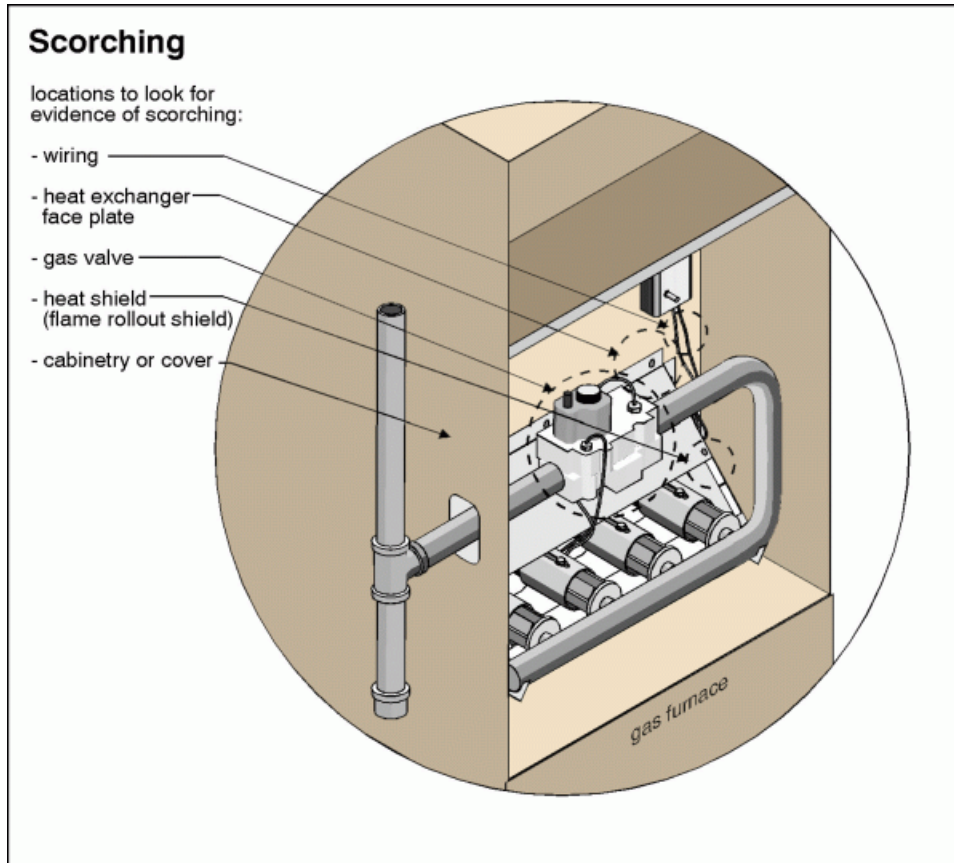
36. Condition: • [Scorching](#)

Implication(s): Equipment not operating properly | Fire or explosion

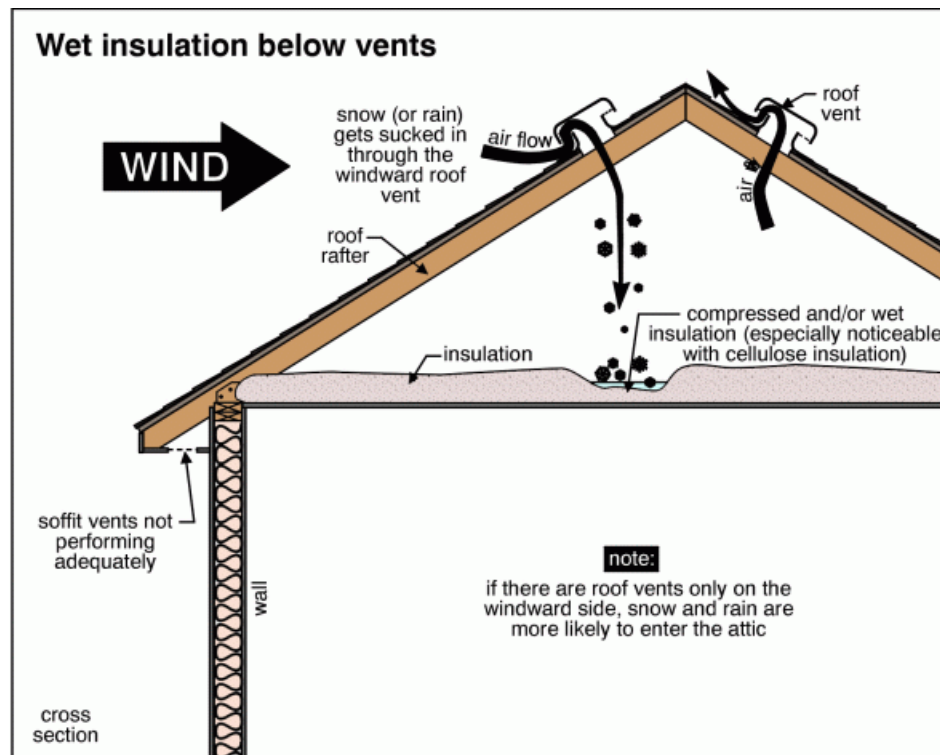
**45. Condition:** • [Compressed](#)

**Implication(s):** Increased heating and cooling costs | Reduced comfort

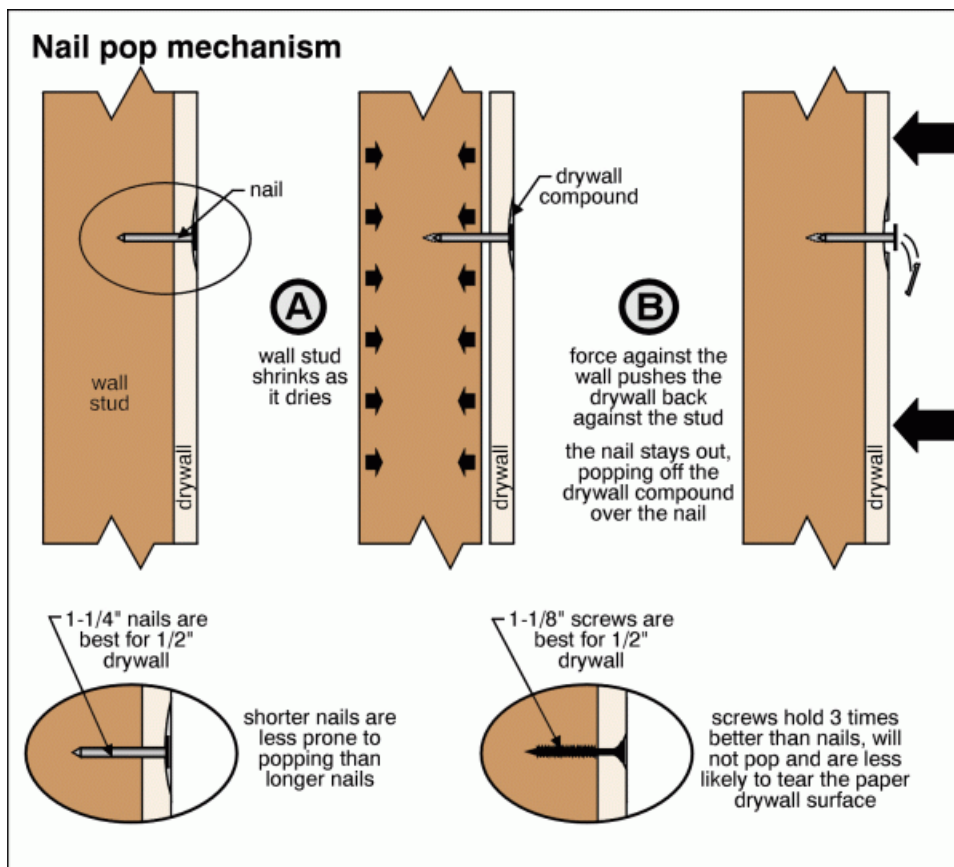
**54. Condition:** • [Nail pops](#)
